Survey of Chatterley Whitfield Hill

13 December 2016

1) Introduction

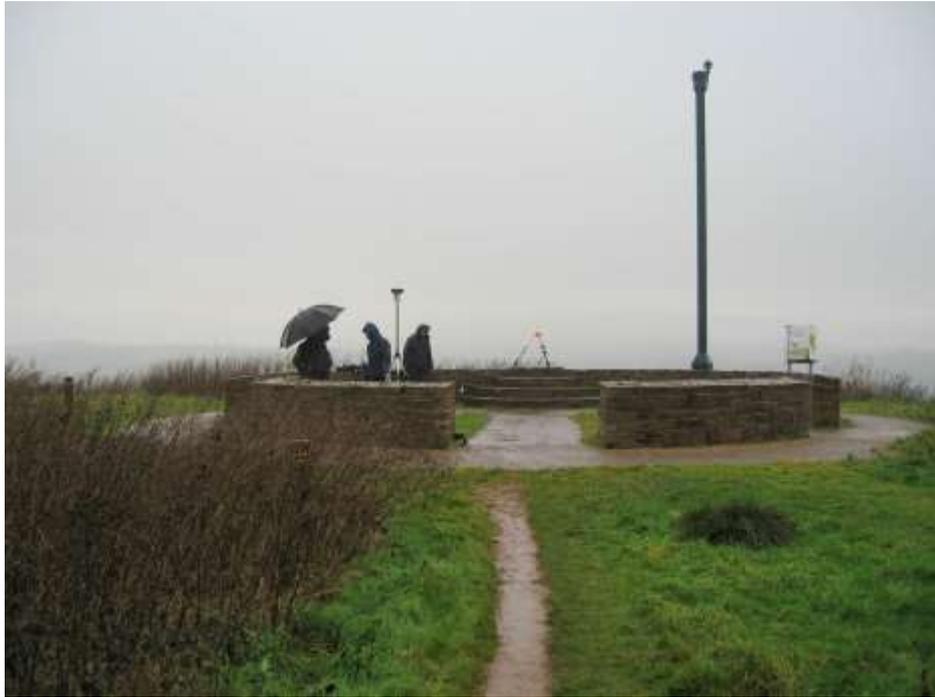
The stone wall with prominent pole behind (point 2)

Summit 2: ground within circular stone wall: (SJ 88266 52908): staff reading = 1.753m

Summit 2 (ground within circulate stone wall) = $209.390 - 1.753 + 1.165 = 208.80\text{m}$

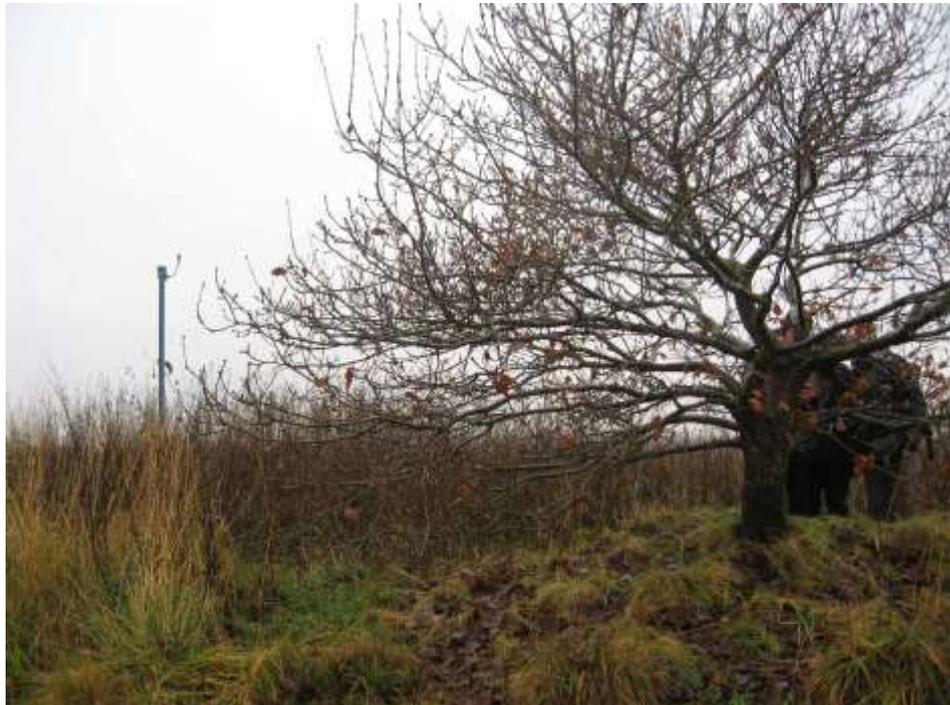
The summit position (point 1) by oak tree about 50m NE of stone circle

Summit 1: ground by oak tree: (SJ88313 52930): staff reading = 1.165m

The **summit of Chatterley Whitfield Hill** is at grid reference * SJ 88312 52936 and is unfeatured ground by a small oak tree. Its height is **$209.4 \pm 0.07\text{m}$** .

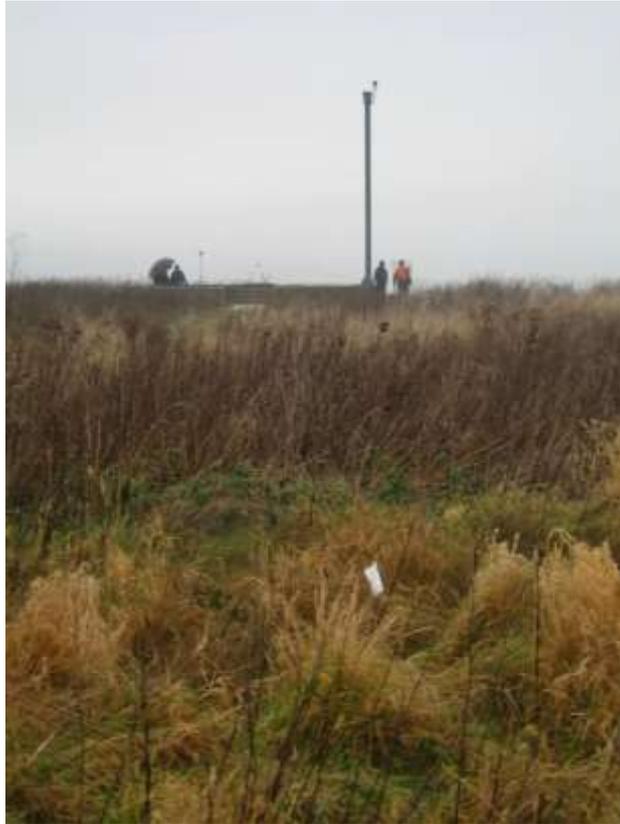
Point 4 about 70m SE of stone circle

Summit 4: no feature: (SJ 88305 52839): staff reading = 1.919m

Summit 4 (no feature) = $209.390 - 1.919 + 1.165 = 208.64\text{m}$

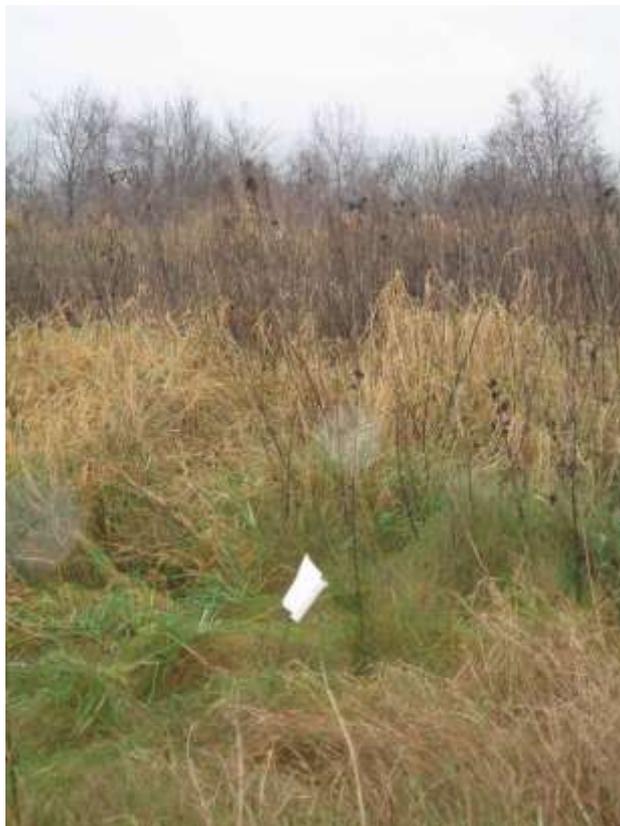
Point 3 about 80m SSE of stone circle: Point 4 is 20m behind in the thick vegetation

Summit 3: no feature: (SJ 88287 52828): staff reading = 1.839m

Summit 3 (no feature) = $209.390 - 1.839 + 1.165 = 208.72\text{m}$

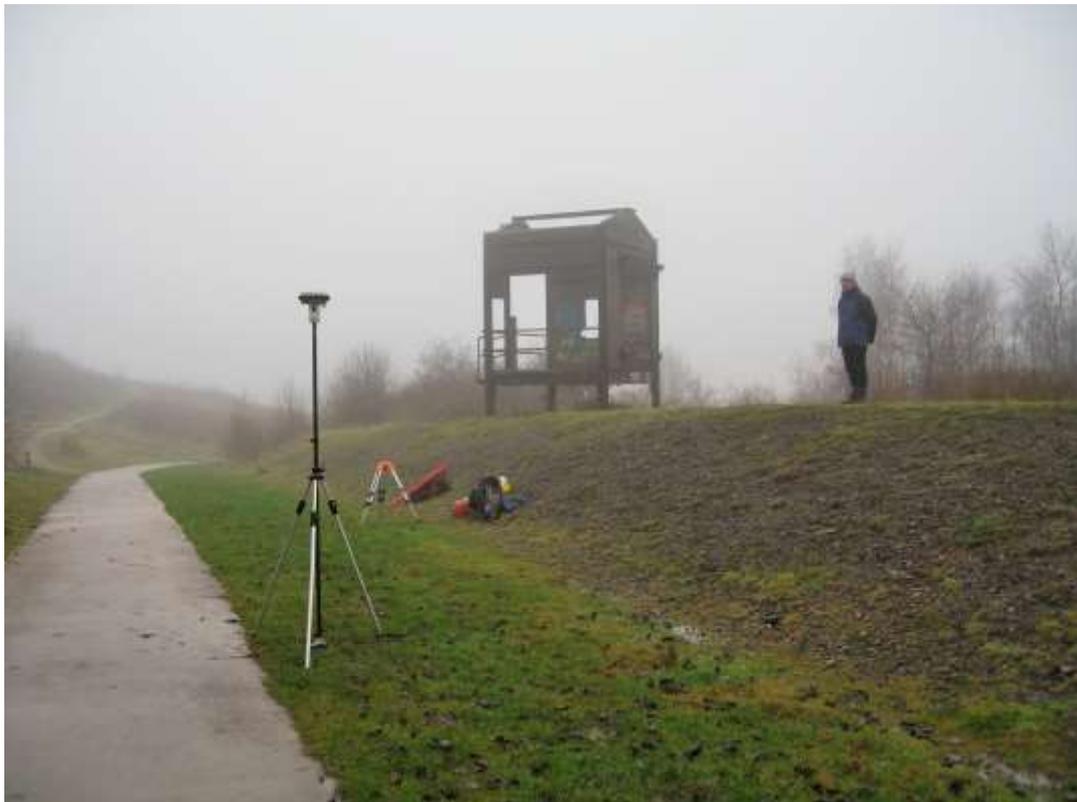
Position on path about 250m from true col

The Leica NA730 level was setup on a tripod on the North edge of the path and staff readings were taken along the path thus enabling us to locate accurately the highest point. Next, the Leica Viva GS15 was setup on a 2.000m pole and supported by a Quickset tripod at this position. GNSS data were then collected for 53 minutes with an epoch time of 15 seconds.

The height of the position on the path is 178.37m

The drop from the summit to the point on the path is 31.03m
