Survey of Stob na Boine Druim-fhinn

06 May 2016

Surveyors – John Barnard and Graham Jackson of G&J Surveys.

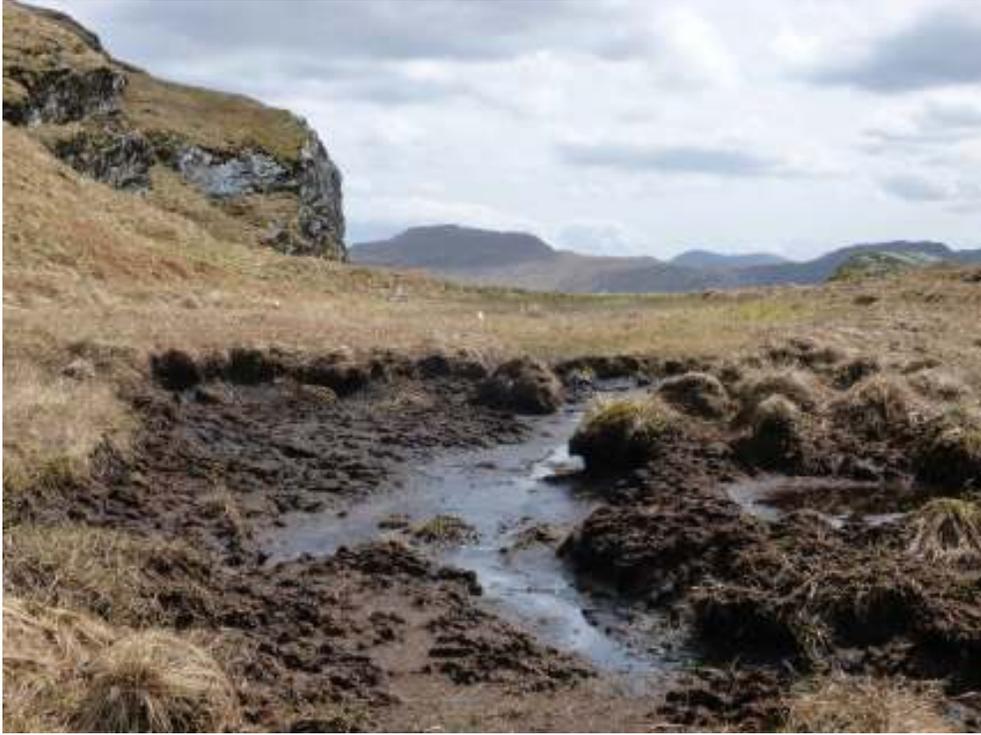
Bealach looking East showing outflow on West side

Photographs of the area of the bealach taken from approximately each of the four main compass points are shown in Appendix 1. All measurements in the boggy area yielded a staff reading of 2.36m the same as that of the water’s surface showing how flat the bealach area was. An important feature of the bealach is that there are two outflows from the “lochan” shown to the left and right in the diagram. Therefore, the bealach position lies at one or both of the outflow positions. Staff readings taken around the edge of the “lochan” were very consistent and showed this whole area to be quite flat as readings only varied by about 0.05m. Given the extremely boggy nature of the ground it was not possible to collect GNSS data at either outflow position. Instead the Leica Viva

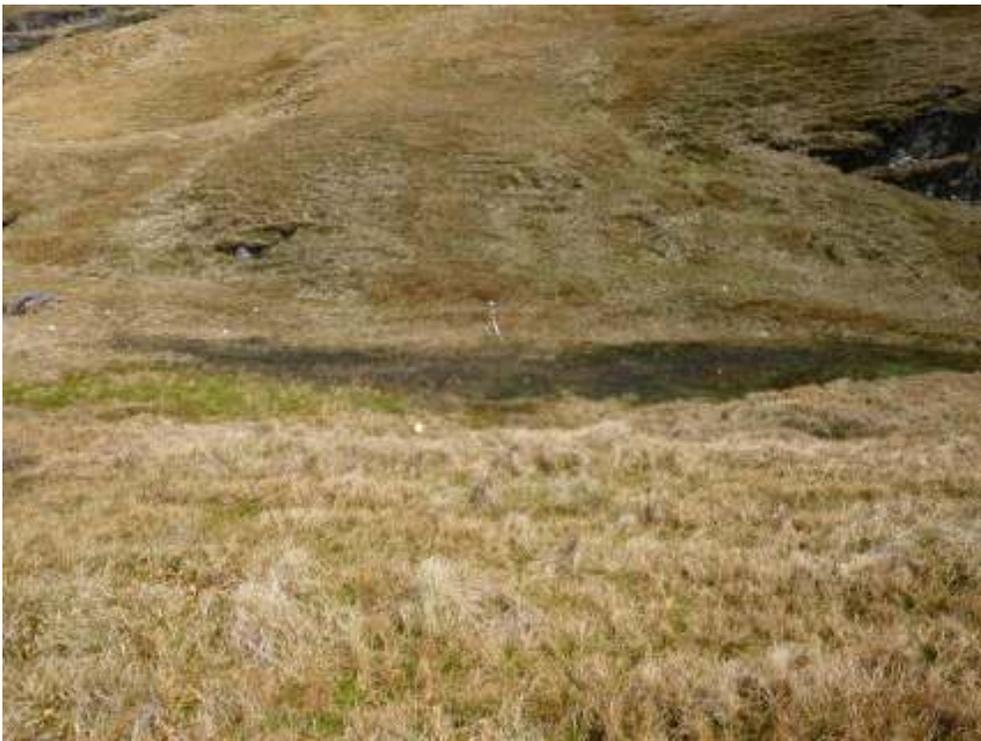
Bealach looking North

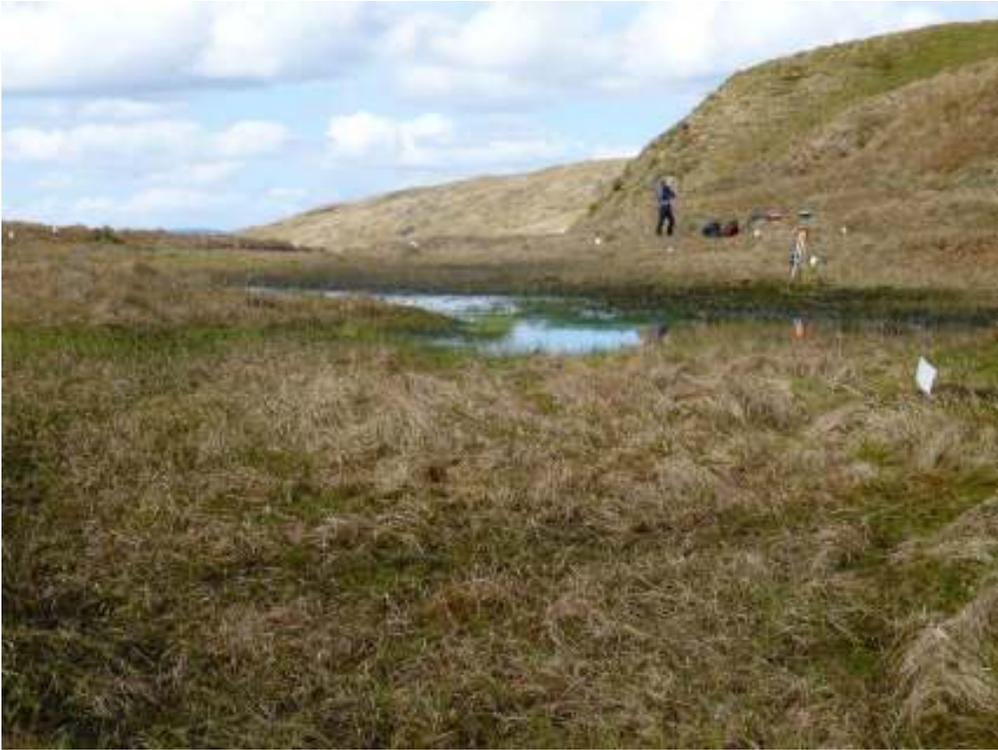
Bealach looking West

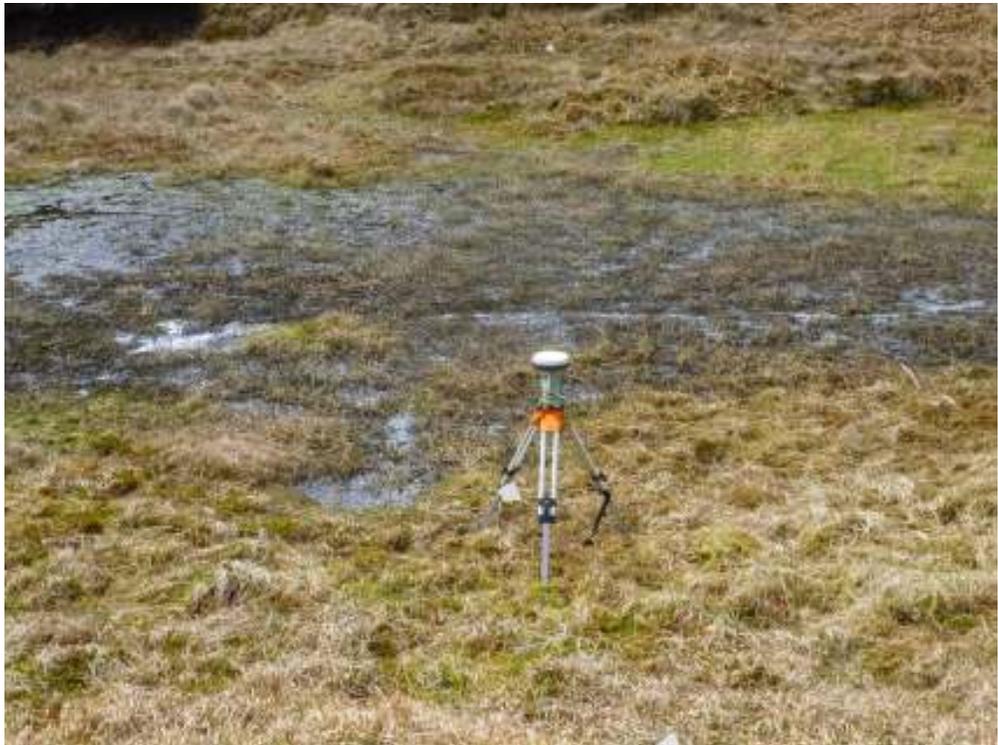
Leica GS15 collecting data at a convenient position on bealach area, photo looking South

The Leica Viva GS15 was set up over the above chosen position using the short tripod configuration (see photo in Appendix 1). The height of the receiver above the ground was then measured with the integral tape. The vertical offset from measuring point to the ground was 0.604m (see photograph in Appendix 1) plus 0.255m for the tribrach/hook system. GNSS data were collected for 2hr with an epoch time of 15 seconds.

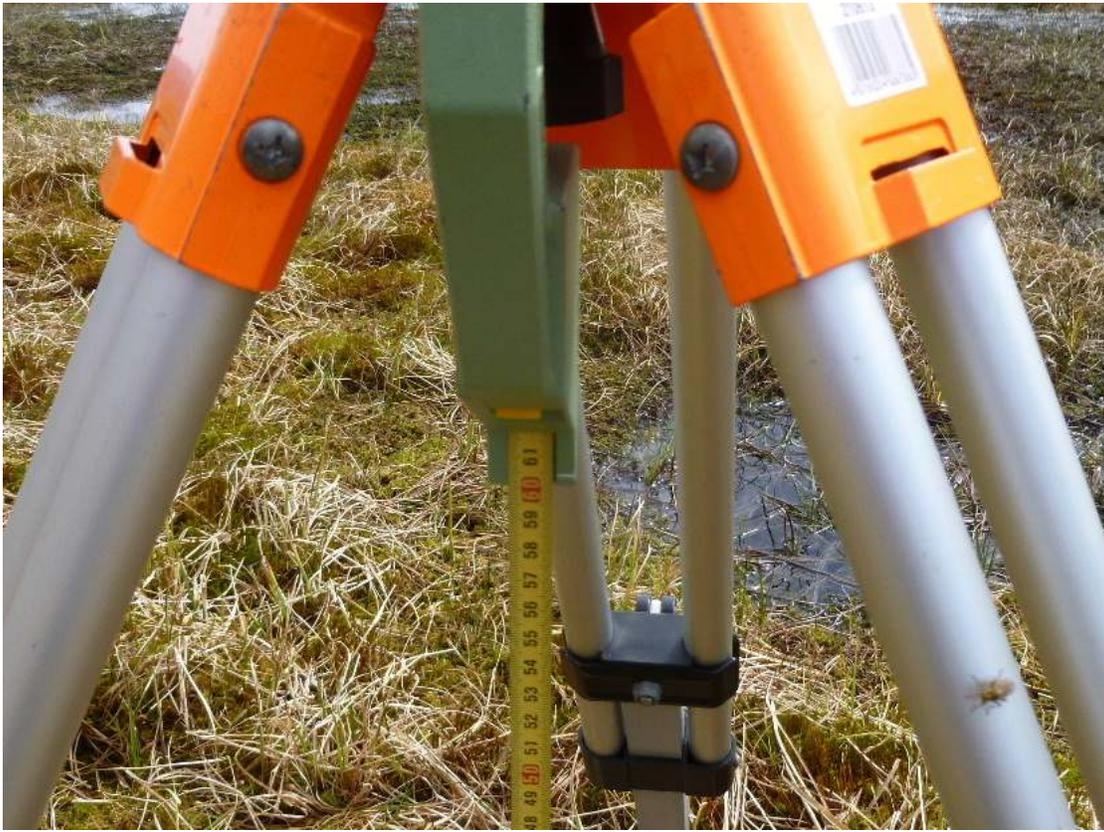
Measuring the Offset, 0.604m, for the GS15 on the beach

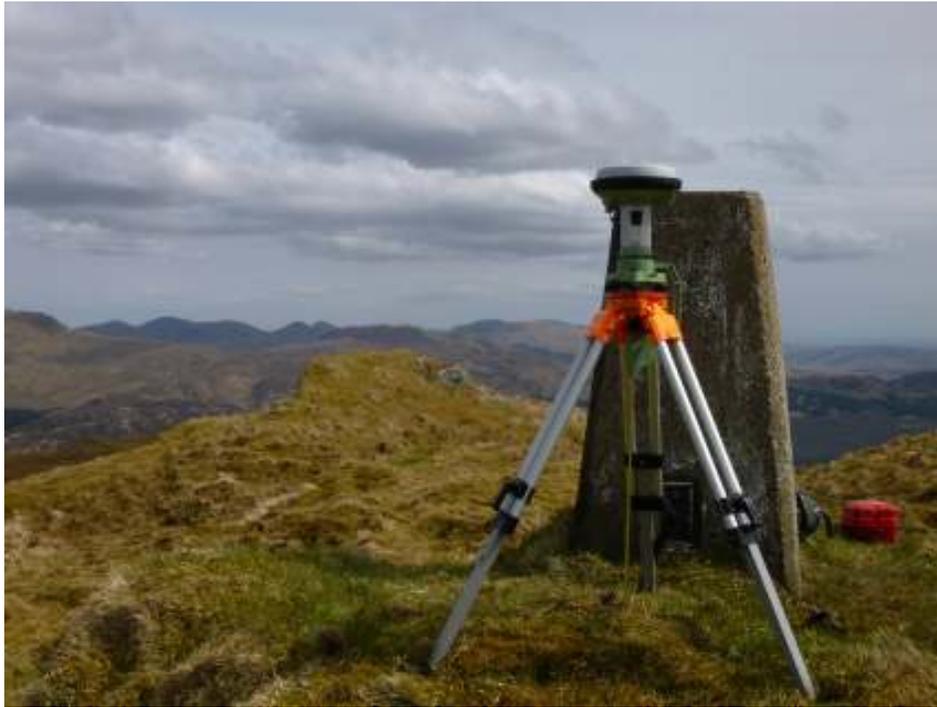
Leica GS15 Collecting data on the Summit

Next the tripod was set-up over the summit position and the Leica Viva GS15 was then fixed to it with a clamp and tribrach (the “short tripod” configuration). The height of the receiver above the ground was then measured with the integral tape. The vertical offset from measuring point to the ground was 0.556m (see photograph in Appendix 2) plus 0.255m for the tribrach/hook system.

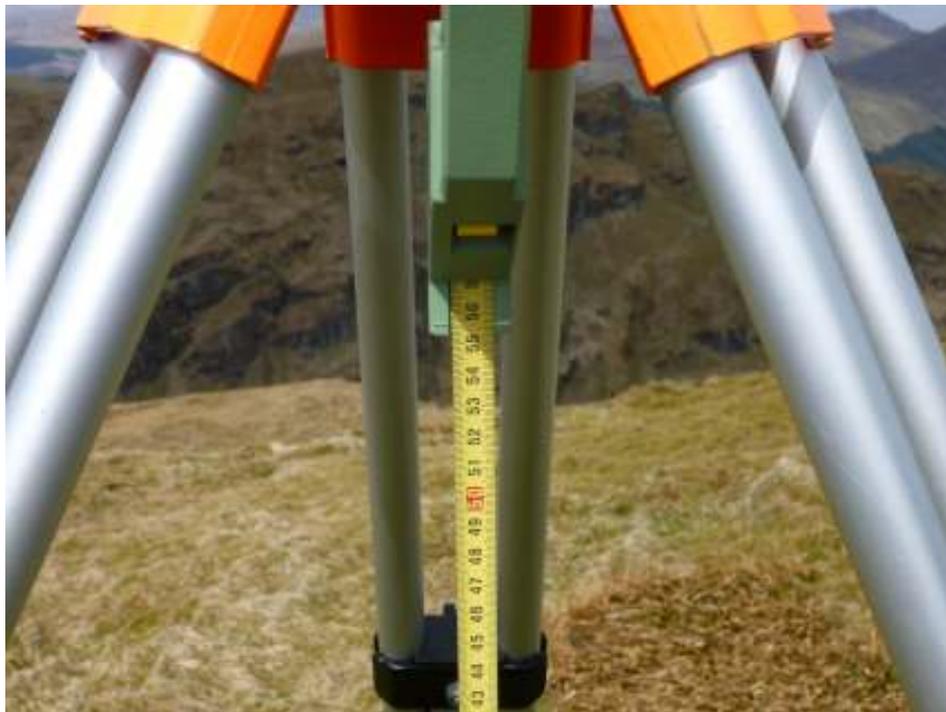
Measuring the offset, 0.556m, for the Leica Viva GS15 on the summit
